# MICROSCOPIC EXAMINATION OF STEEL

HENRY FAY, Ph. D., D. Sc.

*Professor of Analytical Chemistry, Massachusetts Institute of Technology  
Consulting Metallurgist, Watertown Arsenal*

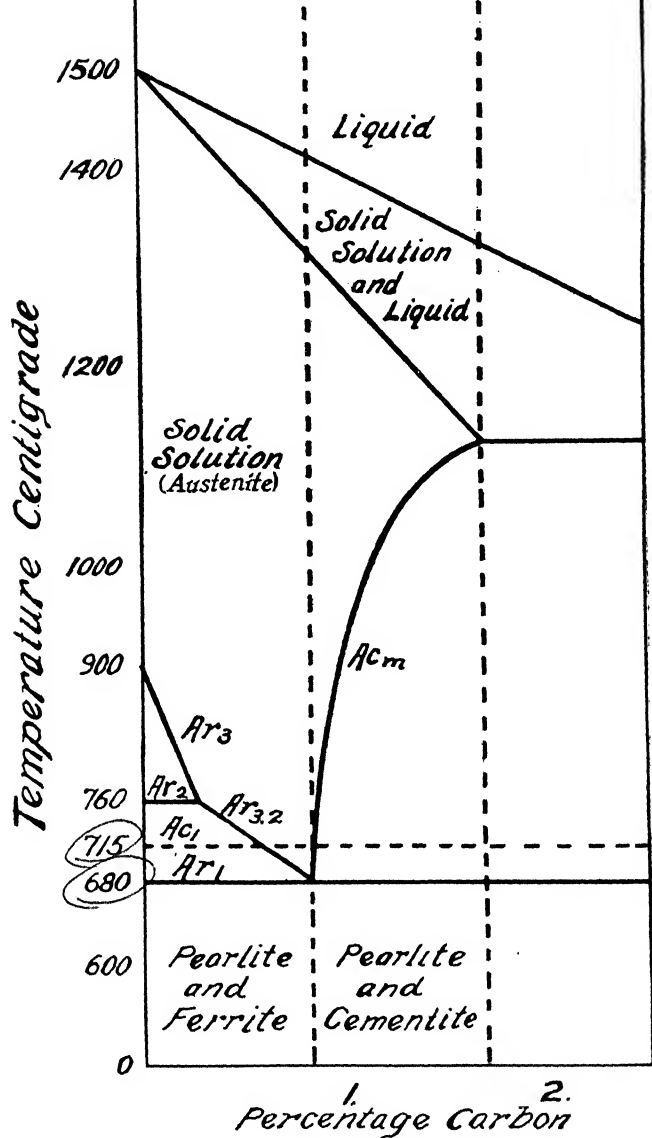
Fig. 1

Portion of iron-carbon diagram

constituents, iron and iron carbide. The  $Ac_1$  point is approximately  $30^\circ$  higher than the  $Ar_1$  point, and represents the beginning of the formation of solid solution. In steels containing 0.85 per cent carbon there is but one critical temperature at which the solid solution decomposes into its constituents, iron and iron carbide. This is known as an eutectoid steel, and its microscopic constituent is pearlite. Pearlite always etches dark, and under high magnifications is shown to consist of alternate laminations of iron and iron carbide. Steels containing less than 0.85 per cent carbon are hypoeutectoid, and contain the microscopic constituents ferrite and pearlite, the amount of the latter increasing with the per cent of carbon. Steels containing more than 0.85 per cent carbon are hypereutectoid, and contain the microscopic constituents cementite (iron carbide,  $Fe_3C$ ) and pearlite. These facts are illustrated in the diagram. (Fig. 1.)

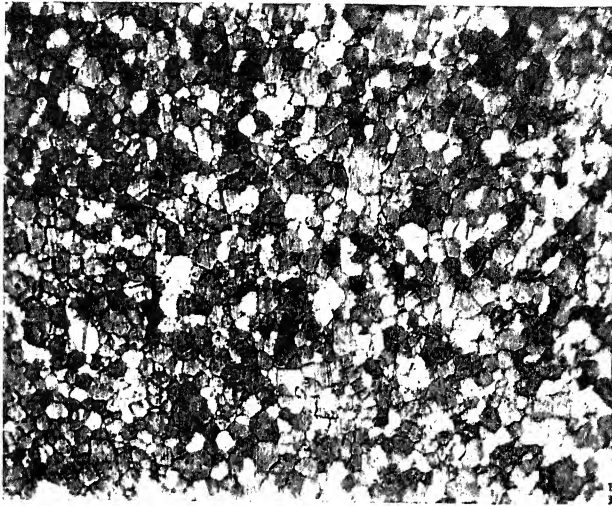
PHOTOGRAPH NO. 1. X75.

0.06% carbon. Approximately pure ferrite.

Photograph No. 1 shows the characteristics of a carbonless iron in which the whole field is made up of granules of ferrite. With the introduction of carbon there is a decrease in the amount of ferrite and the constituent pearlite begins to appear. This is shown in photograph No. 2 for a steel containing 0.18 per cent carbon. Inasmuch as steels containing 0.85 per cent carbon contain 100 per cent pearlite, and as pearlite is composed of ferrite and cementite, in this steel containing 0.18 per cent carbon there ought to be approximately 20 per cent of the field made up of pearlite. In a steel containing 0.5 per cent carbon there should be 58.8 per cent pearlite. Such a steel is shown in photograph No. 4. A eutectoid steel containing 0.83 per cent carbon and practically 100 per cent pearlite is shown in photograph No. 7. Under higher magnifications pearlite shows the laminated structure shown in photograph No. 8. In hypereutectoid steels the excess carbon beyond that necessary to form pearlite, separates as free cementite and the amount of free cementite can be calculated. Inasmuch as the whole field is made up of pearlite

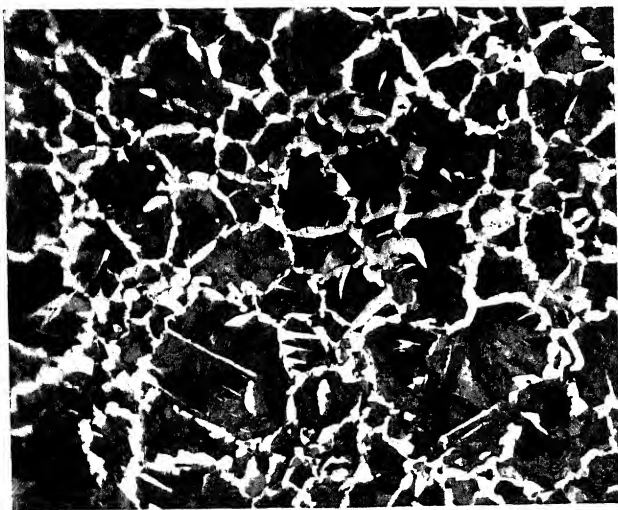
PHOTOGRAPH NO. 4. X75.

0.49% carbon. Ferrite (white) and pearlite (dark).

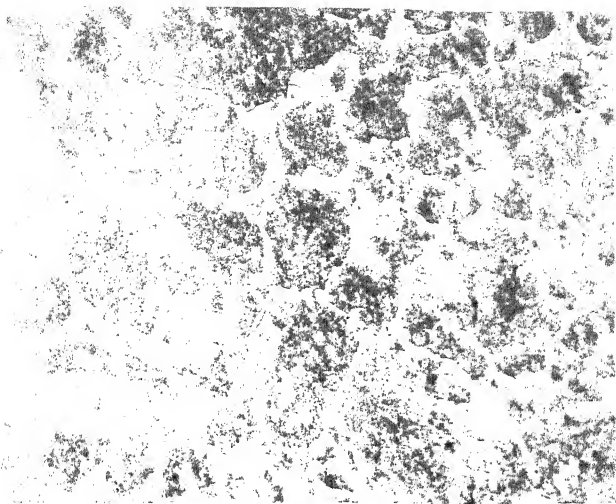
PHOTOGRAPH NO. 5. X75.  
0.57% carbon. Ferrite and pearlite.

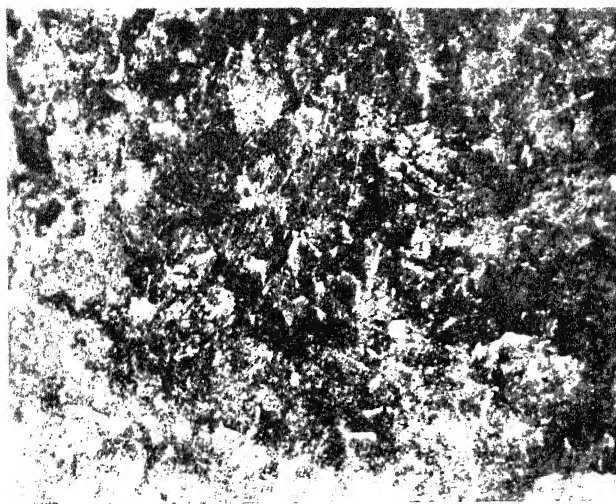
PHOTOGRAPH NO. 6. X75.  
0.71% carbon. Ferrite and pearlite.

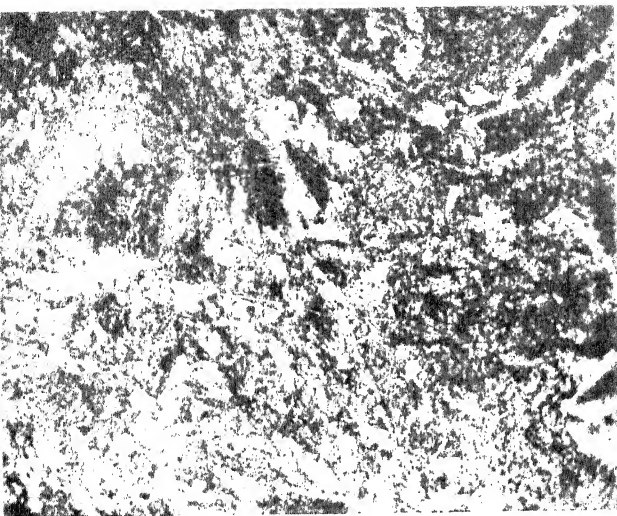
PHOTOGRAPH NO. 7. X75.

0.83 % carbon. Pearlite.

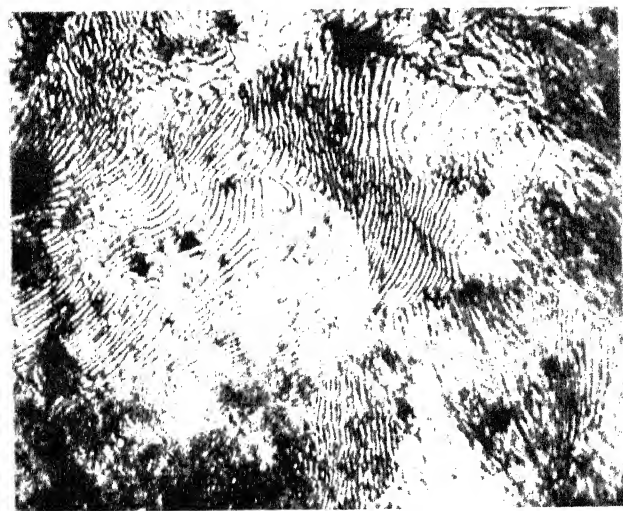
PHOTOGRAPH NO. 8. X485.

0.83 % carbon. Pearlite.

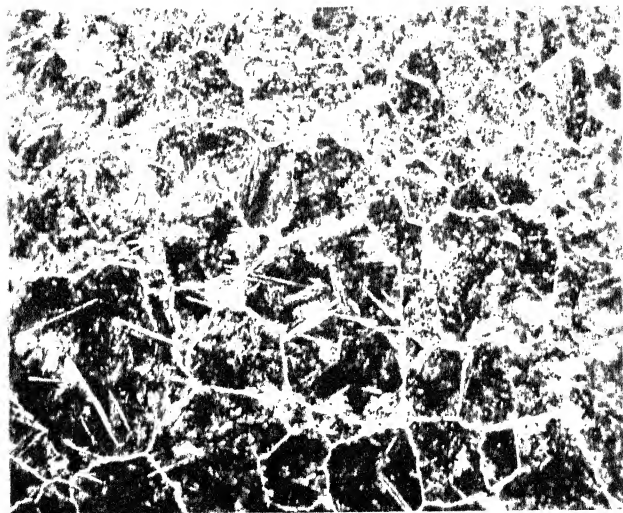
PHOTOGRAPH NO. 10. X75.  
1.46 % carbon. (Pearlite and cementite (white).

and cementite and it requires 0.85 per cent of the carbon to form the pearlite, the difference between the total carbon and 0.85 per cent carbon gives the amount of carbon available to form cementite. Thus in a steel containing 1.25 per cent carbon there is available for cementite formation 0.4 per cent carbon and as cementite,  $\text{Fe}_3\text{C}$ , contains 6.67 per cent carbon the 0.4 per cent carbon would furnish approximately 6 per cent cementite which would occur in the free state, and the steel would contain 94 per cent of pearlite and 6 per cent cementite. See photograph No. 9. It is thus evident that by microscopic examination a rough determination of carbon may be made on *slowly* cooled steels. Photograph No. 10 shows a steel containing 1.46 per cent carbon — approximately 9 per cent cementite — in which the white constituent is cementite.

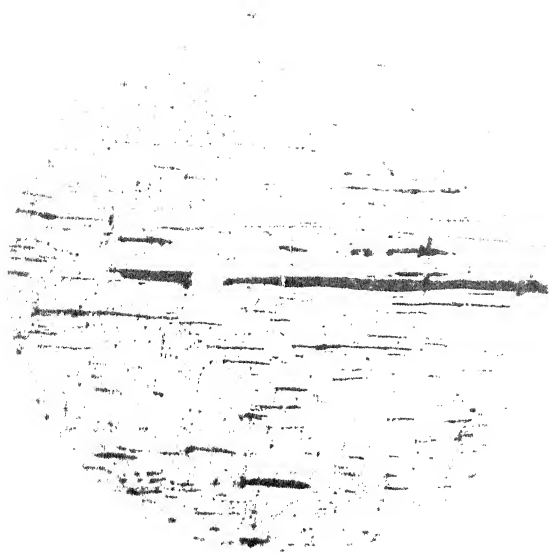
PHOTOGRAPH NO. 17. X50.

Slag elongated in direction of forging. Specimen unetched.

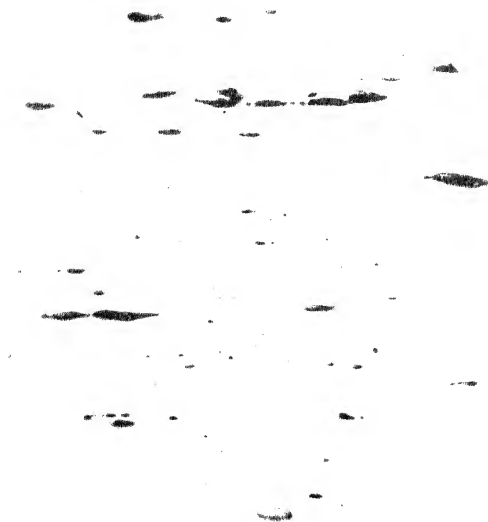
PHOTOGRAPH NO. 18. X50.

Unevenly distributed slag. Specimen unetched.

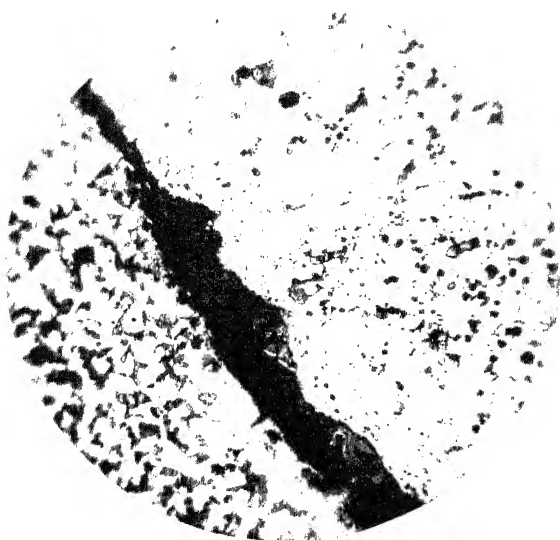
PHOTOGRAPH NO. 24. X50.

Crack, slag, and decarbonized area found on the base of a steel rail.

The inclusion of oxide is frequently accompanied by partial decarbonization, and is most frequently found on or near the surface. An example of this is shown in photograph No. 24, in which it is seen that a crack has penetrated through the slag, probably mill scale, and in the crack are the remnants of the slag. On the left of the crack is the normal structure and on the right is a decarbonized area containing slag. Such an area would probably be large enough to show to the naked eye and would be considered unsafe. Other examples of oxide inclosures are cited on pages 14 and 15, in the discussion of the failure of 10-inch gun and 14-inch gun lever.

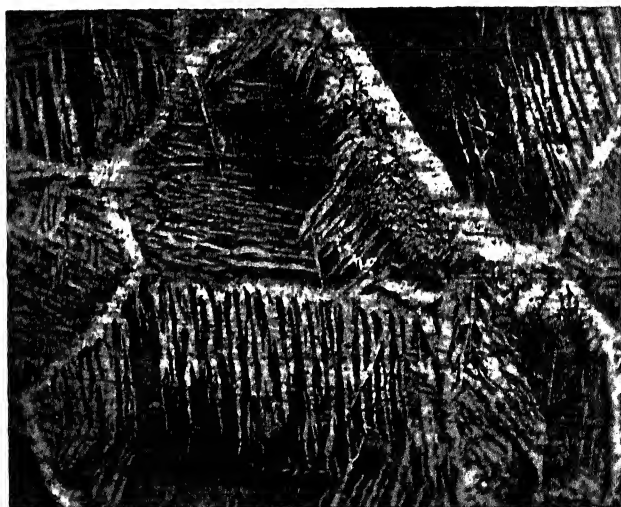
PHOTOGRAPH NO. 33. X75.

Microstructure of overheated steel.

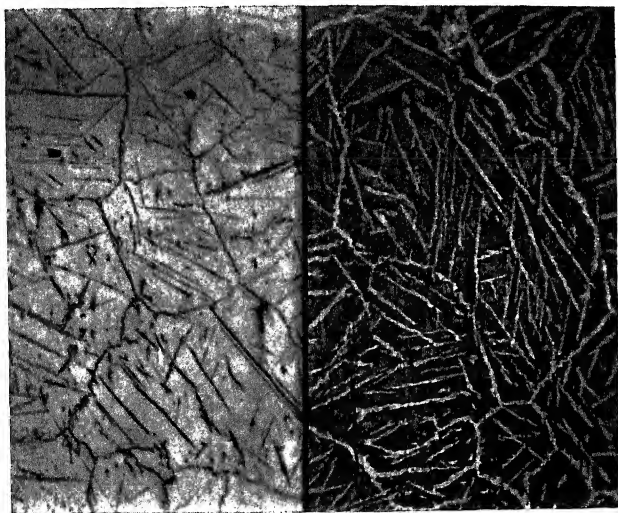
PHOTOGRAPH NO. 35. X65.

Microstructure in center of broken recoil spring showing excess cementite, indicating high carbon. Left, white lines are cementite etched with nitric acid solution; right, dark lines are cementite etched with sodium picrate solution.

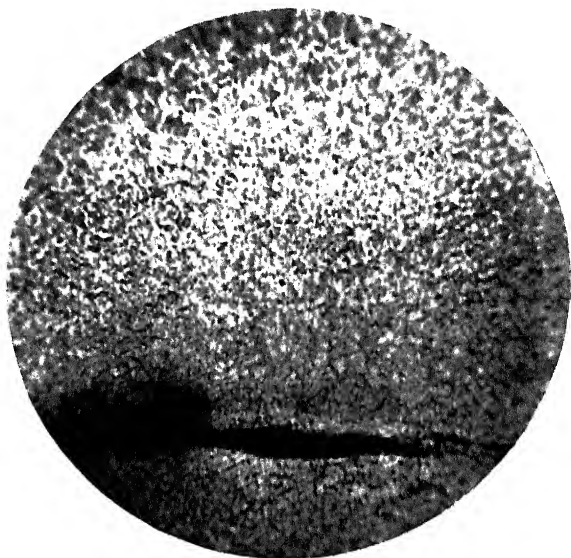
PHOTOGRAPH NO. 40. X50.

Crack and slag, with decarbonized area in 10-inch rifle.

Examination of sections in the vicinity of the crack showed many fine cracks, slag inclusions, and carbonless areas. The cracks led to slag, and where the slag was found there were also found decarbonized areas. Photograph No. 40 shows a crack ending in slag and surrounded by decarbonized iron. The course of the slag was quite irregular, as shown in photographs Nos. 41 and 42.

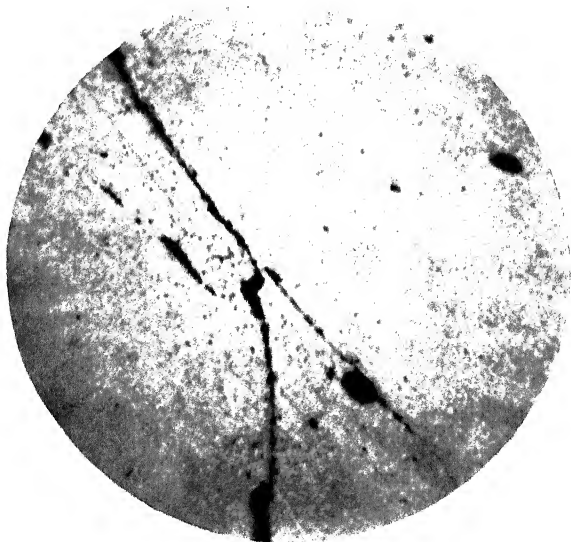
PHOTOGRAPH NO. 41. X50.

Slag in 10-inch rifle, unetched.

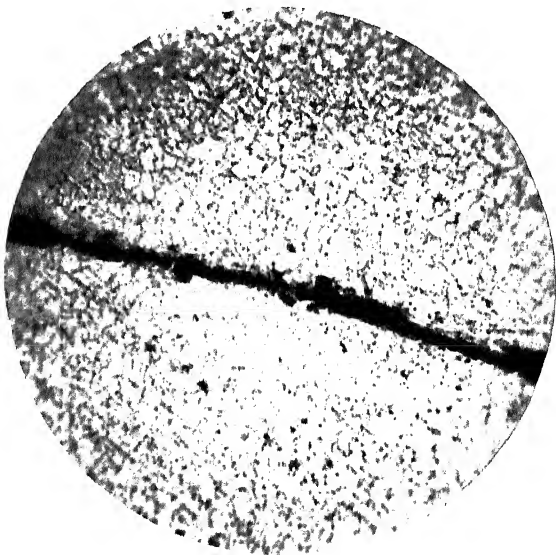
PHOTOGRAPH NO. 43. X50.  
Slag and decarbonized area in 10-inch rifle.

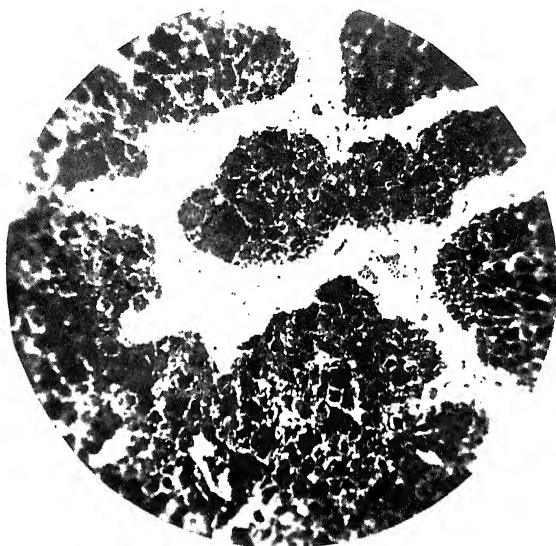
PHOTOGRAPH NO. 48. X50.

Fourteen-inch gun lever. Segregated ferrite (white) with slag inclusions.

In the fractured ends of the test pieces the metal shows decidedly bright spots, and these are due, it is believed, to the presence of the segregated ferrite. Further, it has been noticed that along the stem of the test pieces incipient cracks are developed, as shown in photograph No. 45. It is highly probable that these incipient fractures are developed in such areas as shown in photograph No. 47, which shows a large ferrite field at the edge of the specimen. It is possible that if the forces are transmitted equally throughout the test piece that such a portion would yield more readily where the carbon was lowest. The strength of such a spot would be approximately that of pure iron, or about 40,000 pounds per square inch, while the darker areas which contain more carbon would show considerably higher values. The presence of much slag in the ferrite areas would also increase the brittleness at this point, and would account for the low ductility in some specimens. Further examples of this form of segregation are shown in photographs Nos. 48 and 49.

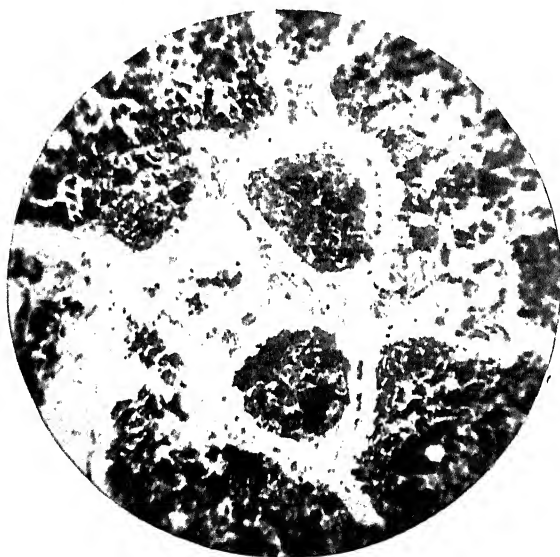
PHOTOGRAPH NO. 49. X50.

Fourteen-inch gun lever. Segregated ferrite with slag inclusions.

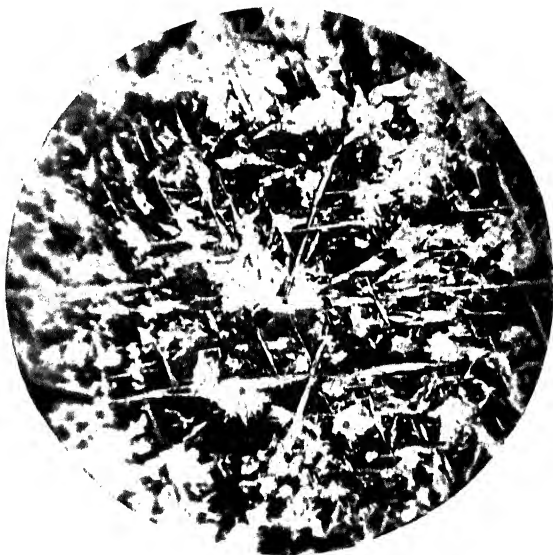
PHOTOGRAPH NO. 51. X50.

Fourteen-inch gun lever. Crystalline structure.

The metal has not been annealed in such a way as to remove the original crystallization which took place at the time of solidification. The crystalline structure is shown in photographs Nos. 50 and 51. Proper annealing should have completely wiped out all appearance of this kind. Evidence of this crystalline nature was found in all specimens examined, and it is highly

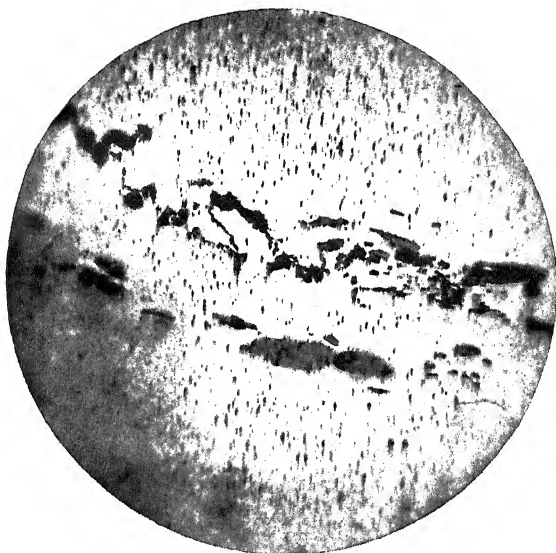
PHOTOGRAPH NO. 54. X50.

Twelve-inch gun. Slag in unetched specimen.

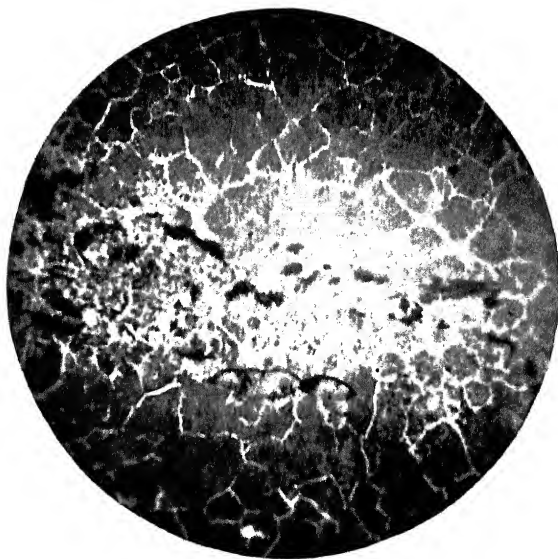
PHOTOGRAPH NO. 55. X50.

Twelve-inch gun. Same area as No. 54, etched with alcoholic nitric acid.
